Gibbs Passive House Study:
A case study approach for a historic residential
energy efficiency renovation

A thesis submitted to the Graduate College
in partial fulfillment of the requirements
for the degree of Master of Science in Engineering (Mechanical)
Mechanical and Aeronautical Engineering
Western Michigan University
December 2017

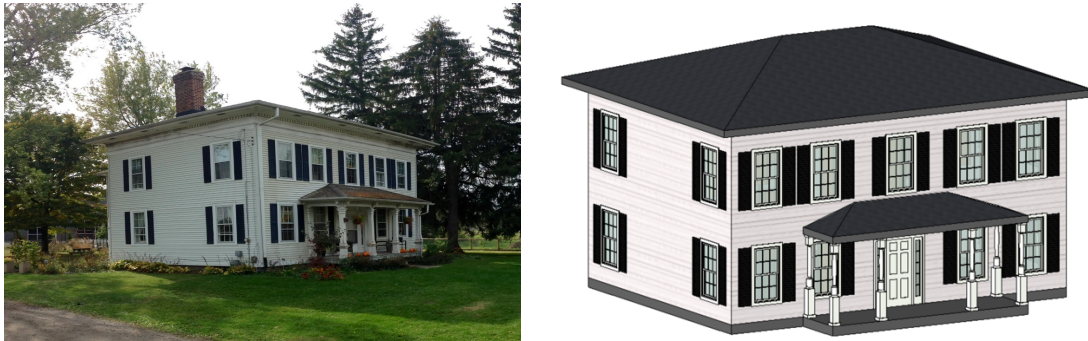
Figure 1: Gibbs House pictured (left); Revit model (right)

The Gibbs House is a historic farmhouse residence built in 1853 and owned and operated by Western Michigan University. The house is located on Parkview Avenue in Kalamazoo, Michigan. The house is a functioning residence with three to five students living in the Gibbs House every year as fellows for the WMU Office for Sustainability. The house is located on a two acre permaculture demonstration and research site.

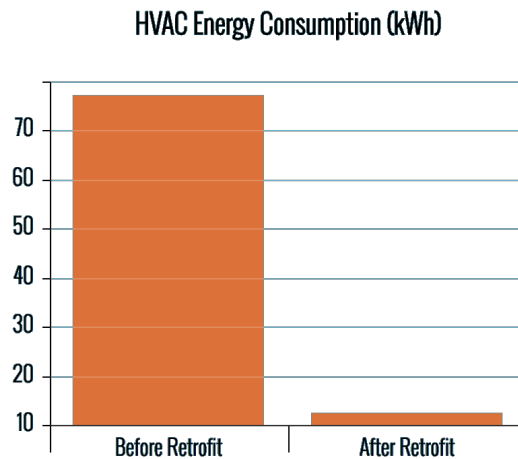
The ReNEWW House operated by Purdue University and Whirlpool Corporation is another older home renovated for energy efficiency and education in a similar climate zone to Kalamazoo, Michigan. During a site visit to the home, the building was found to be a highly technological house retrofitted with an energy recovery unit, rainwater collection and a custom filtration system, hyper-controllability and data logging even down to residents' heat rates, and highly efficient and state of the art appliances and equipment. Mechanical ventilation is provided by an energy recovery unit and heating hot water is provided by a deep geothermal well. Data is available on their website to reveal, for example, that HVAC energy consumption was reduced by approximately 80% after the renovation [13].

Figure 3: ReNEWW House HVAC energy consumption data [67]

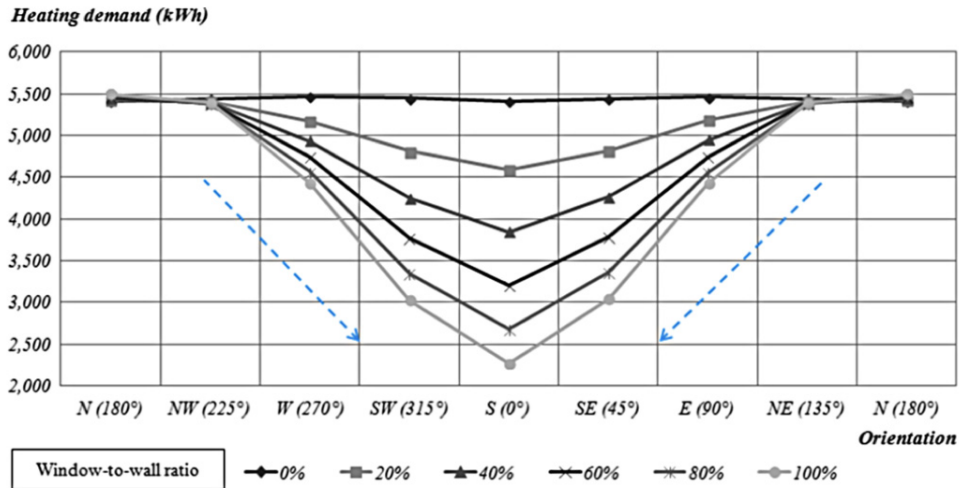
Figure 4 demonstrates two core concepts relating to energy load and building design. First, a wall that is oriented south will receive more direct sunlight, and thus increase heat gain from solar radiation, resulting in a lower heating demand. The building under analysis in Figure 4 is located in South Korea at 37.3 degrees latitude. This latitude is similar to the latitude of the Gibbs House in Kalamazoo, Michigan (47.3 deg N) and thus yields similar thermal behavior according to sun paths in the northern hemisphere. Second, as the window-to-wall ratio increases noting that the U-factor is larger for windows than walls, the heat loss in winter from transmission and the heat gain from solar radiation both increase [15].

Figure 4: Heating demand curves [15]

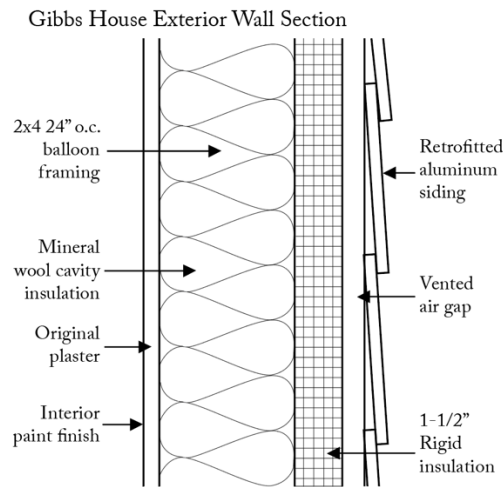
The Gibbs House was built in 1853 on Parkview Avenue in Kalamazoo, Michigan. Since the analysis is based on an existing historic building, little information was initially known about the wall construction and assembly type. Balloon construction was common from the mid-1800s to 1950s [30]. Refer to the Insulation section for details on building envelope assumptions. Material properties of the windows were assumed since the original building documents were not available. The known material properties and dimensions are shown in Tables 6 and 7. Asbestos and lead testing was conducted by WMU Environmental Health and Safety for the specific areas that may be impacted during renovation recommendations.

Figure 5: Gibbs exterior wall section

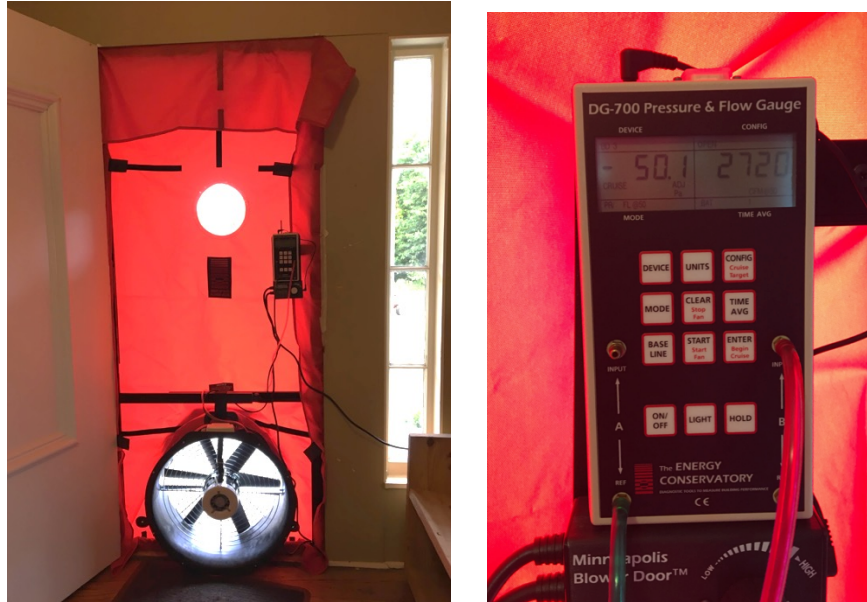
Whole building leakage rates were determined by installing the blower door in the front door, closing all windows, and covering all vents. Tests were conducted for the building as-is, with temporary minor repairs, and custom weatherstripping. The whole building test takes into consideration not just the anticipated fenestration leaks, but all other possible leakage points such as the basement ribbon, chimney, or other envelope leakage points.

Figure 6: Blower door installed for whole building (left); example screen showing 50Pa building pressure (right)

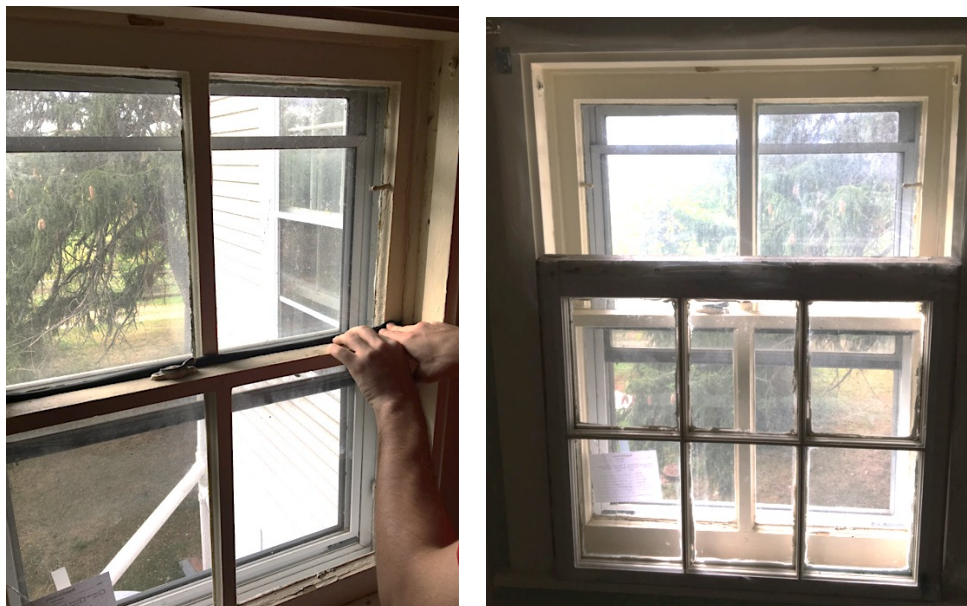
The standalone window tests were conducted to observe leakage rates for the window alternatives on a single room basis. Infiltration data from the blower door, in conjunction with fenestration thermal behavior observed in the other section, is intended to provide a more complete profile for determining the best window upgrade option. The fan controller maintains the building pressure at approximately 50 Pa and airflow reading samples are provided at every two seconds for 1-2 minute intervals after the fan maintained 50 Pa.

Figure 7: Standalone window baseline (left); standalone retrofitted window installed (right)

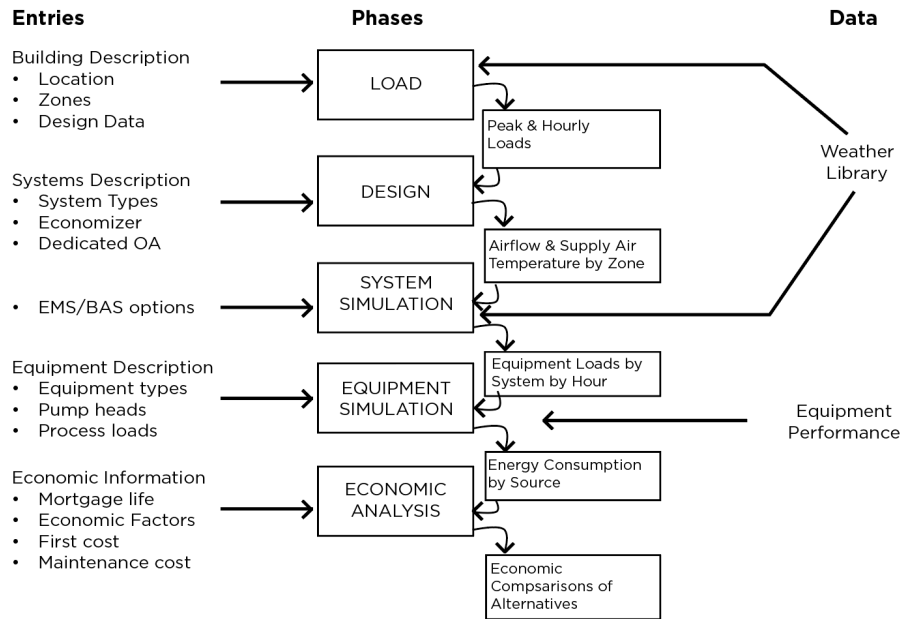
Energy modeling is conducted using Trane Trace 700 software [34]. Trace 700 is a common industry standard for whole building energy modeling based on ASHRAE 90.1-2007 [35] that accounts for weather data, building construction properties, equipment type and sizing, systems configurations, and economic information. The software is built to calculate comparisons across alternatives that allow for the multi-faceted alternative approach developed in this study.

Figure 8: Trace 700 flow chart [34]

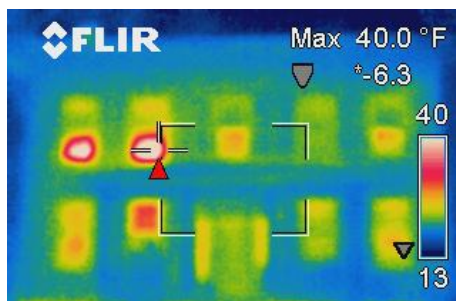
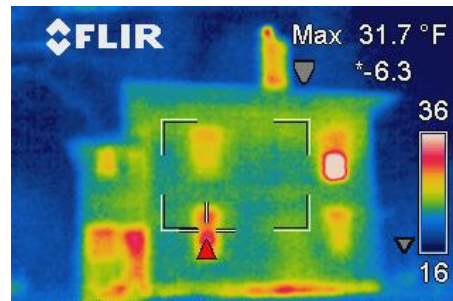
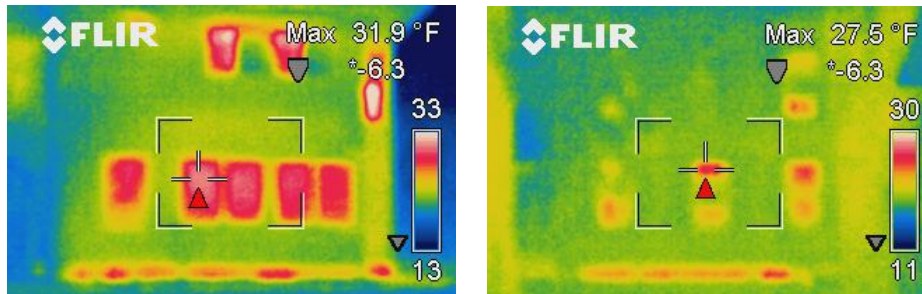
Figure 9: North (top left); east (top right); south (bottom left); west (bottom right) exterior IRT images

Also note the relatively high temperature at the basement ribbon indicating minimal insulation which was verified by visual inspection. The observed heat loss at the ribbon is observable on all building facades. The interior surfaces were also captured using the infrared camera in order to calculate the temperature distribution.

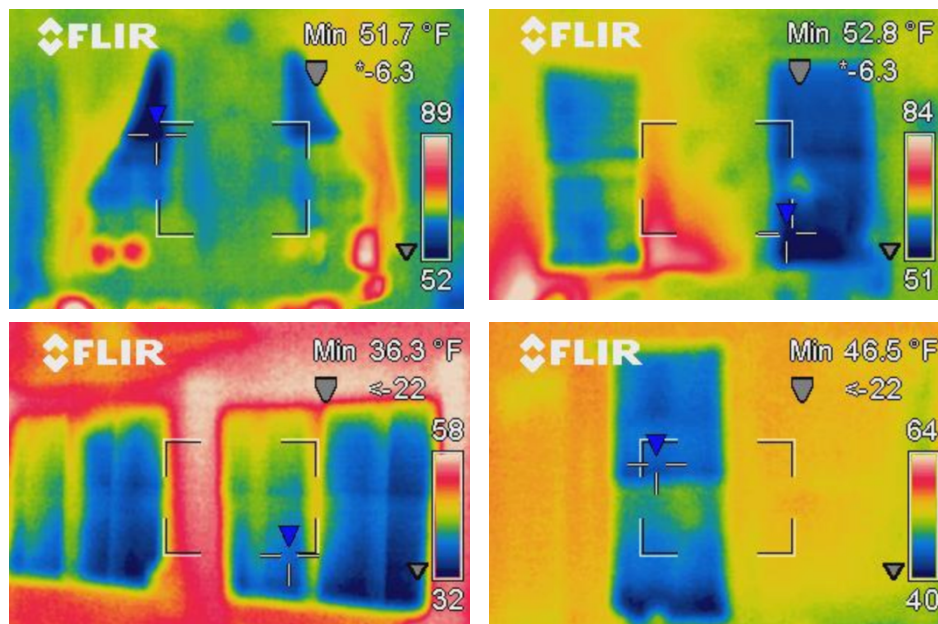
Figure 10: North (top left); east (top right); south (bottom left); west (bottom right) interior IRT images

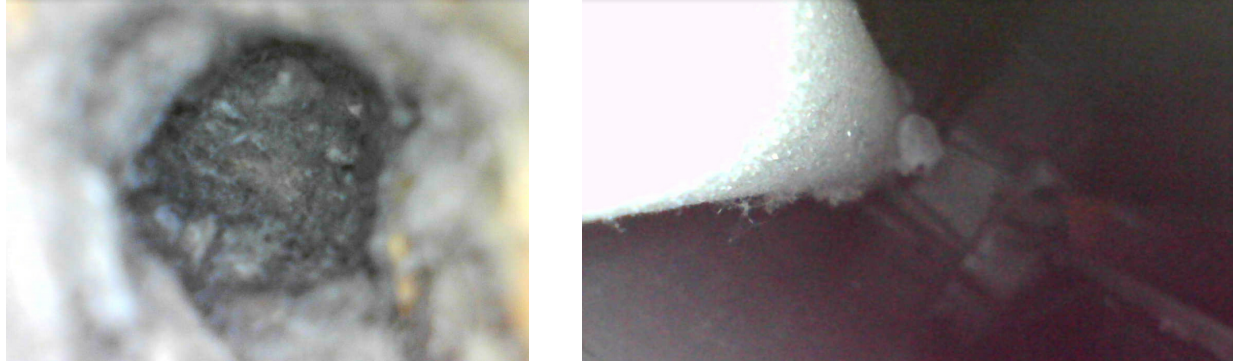
The visual inspection of the wall cavity found less than 5% insulation volume. The existing insulation appeared to be of the mineral wool type and congregated at the base of the wall cavity, no higher than one foot above the floor level. Additionally, the finned tubed piping picture in Figure 11 is uninsulated resulting in excessive heat loss.

Figure 11: Mineral wool insulation at baseboard (left); empty exterior wall cavity at finned tube level (right)

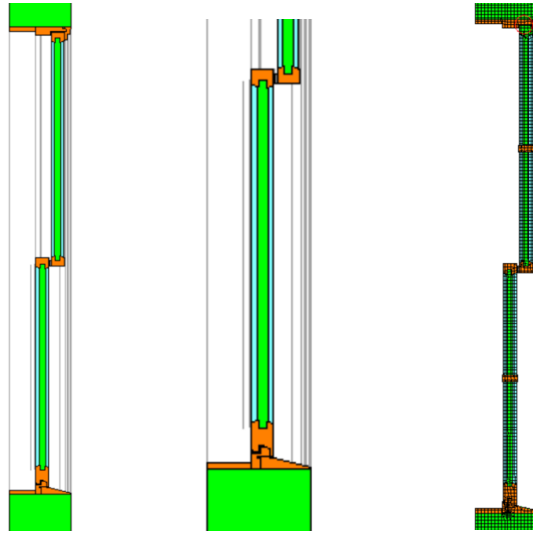
The combined U-factor calculations provided by the finite element analysis highlighted the effectiveness of weatherstripping and film to resist heat loss during the heating season. As expected, the double pane window was found to have the lowest combined U-factor with the weatherstripped film alternate as second lowest. Repairing, refurbishing, and weatherstripping alone yielded U-factors fairly similar to the existing as-is window with less than 7% reductions. Sample cross sectional geometries are shown in Figure 12.

Figure 12: Double pane cross section (left); lower half (middle); full mesh (right) in THERM

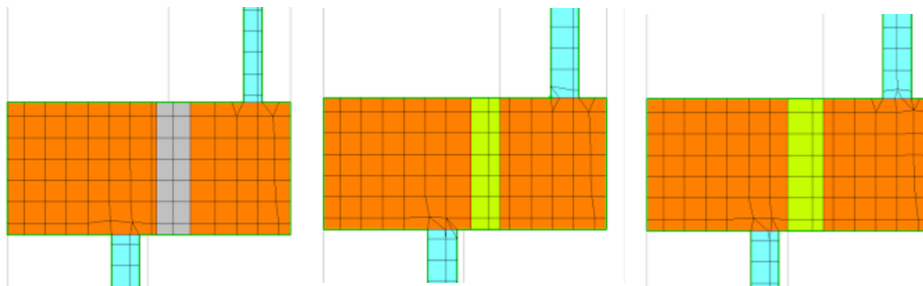
The window middle sashes are shown in Figure 13 as a comparison between alternatives. The as-is window has a small air gap that represents the average window gap across all windows: ranging from nearly tight to wide open. The gap is simulated as a highly conductive material (glass) since THERM requires that the boundary conditions are continuous. Additionally, the gap is smaller in width compared to the other single pane alternatives due to this discrepancy so that the glass material assumption would not interfere with the thermal performance of the overall window assembly.

Figure 13: As-is sash (left); repaired sash (middle); weatherstripped sash (right) meshes

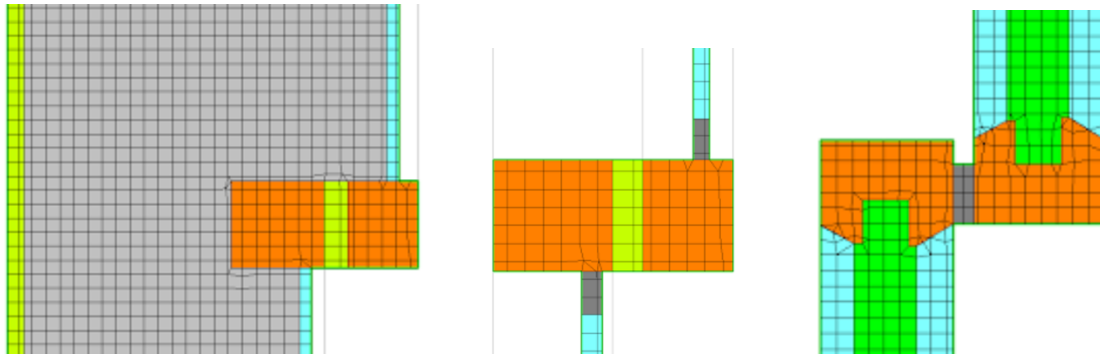
The film alternative, however, was able to be computed using THERM's built-in convection algorithm since the area is completely encompassed by the window assembly.

Figure 14: Weatherstripped film sash (left); refurbished sash (middle); double pane sash (right)

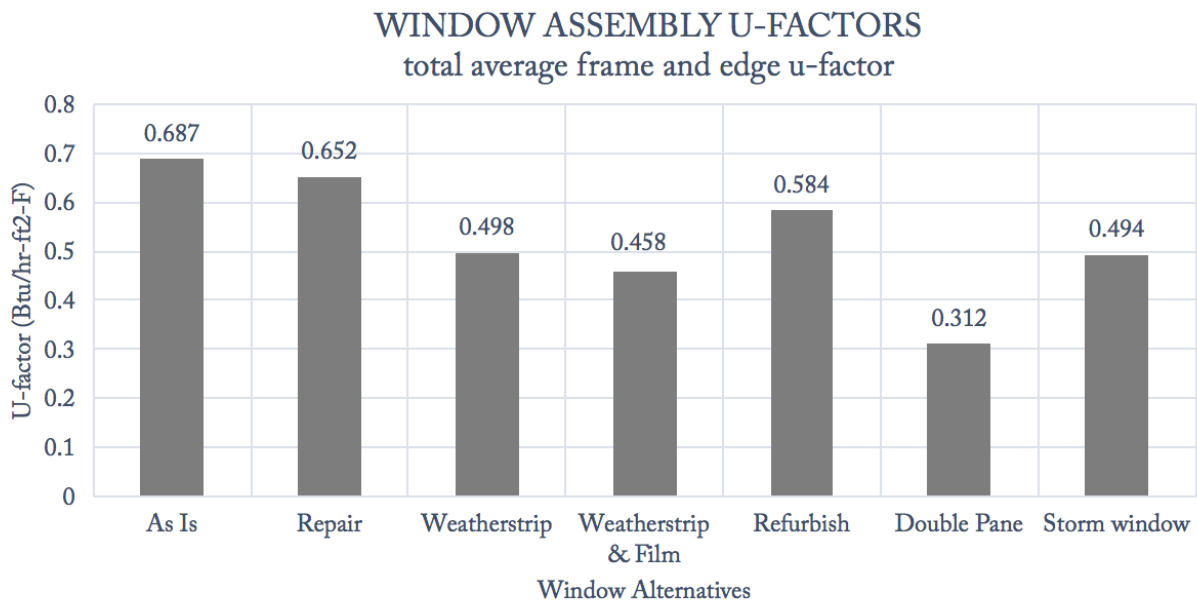
Based on the above inputs, THERM calculated the average U-factor for the entire assembly as shown in the Figure 15. The double pane manufacturer claimed a U-factor of 0.25, whereas the THERM results yielded an overall U-factor of 0.312.

Figure 15: Window assembly U-factors

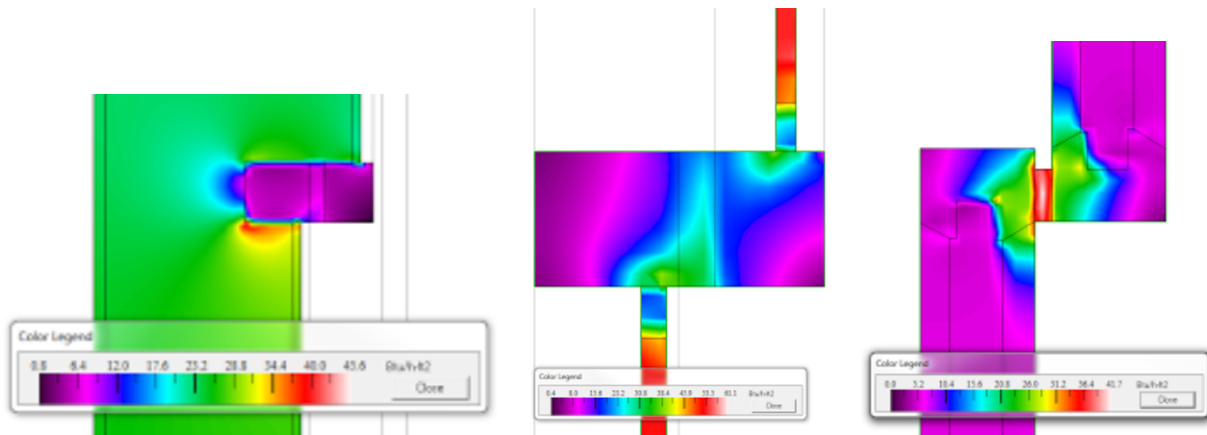
Figure 17: Weatherstripped film (left); refurbished (middle); double pane (right) sash heat flux contours

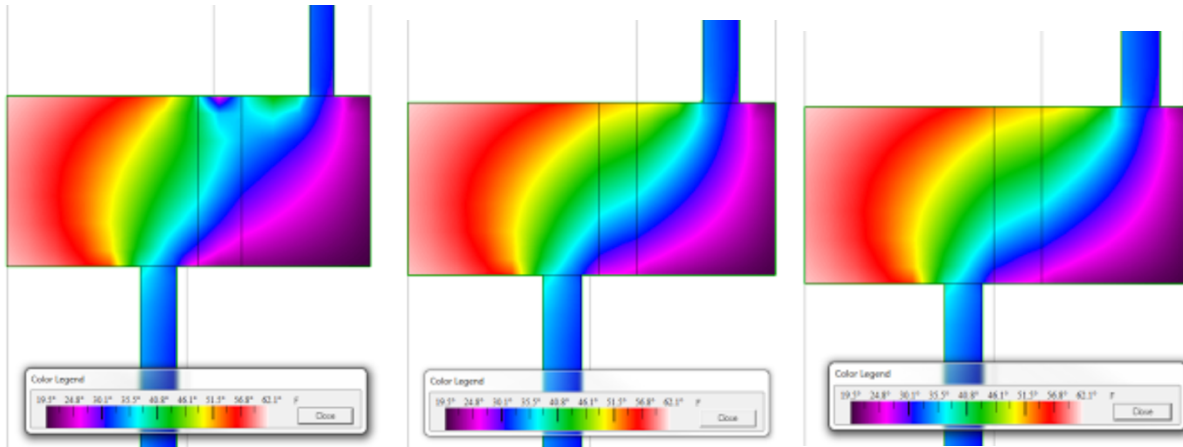
The temperature contour results for the as-is window (pictured left) demonstrate a dramatic temperature drop from the interior (left side) to the exterior (right side). Additionally, note the lower temperature represented by the blue color on the glass portion of the as-is cross section. Comparatively, the double pane window provides an interior surface temperature around 60 degF across both the frame and glazing edge. This provides increased thermal comfort for the occupants based on reduced temperature swings from thermal radiation.

Figure 18: As-is (left); repaired (middle); weatherstripped (right) sash temperature contours

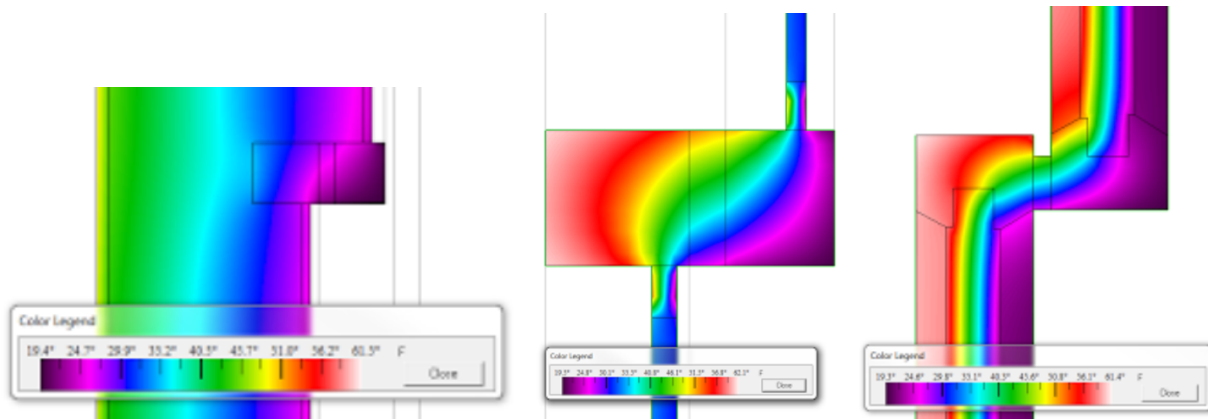
Figure 19: Weatherstripped film (left); refurbished (middle); and double pane sash temperature contours

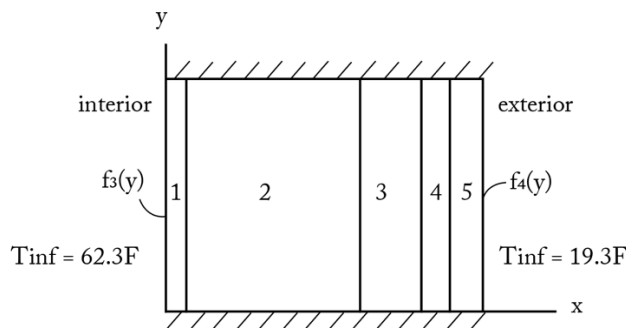
The envelope is comprised of five layers from the interior to the exterior: plaster, mineral wool insulation, rigid insulation, air gap, and aluminum exterior siding (as shown in diagram Figure 20).

Figure 20: Two dimensional wall assembly diagram

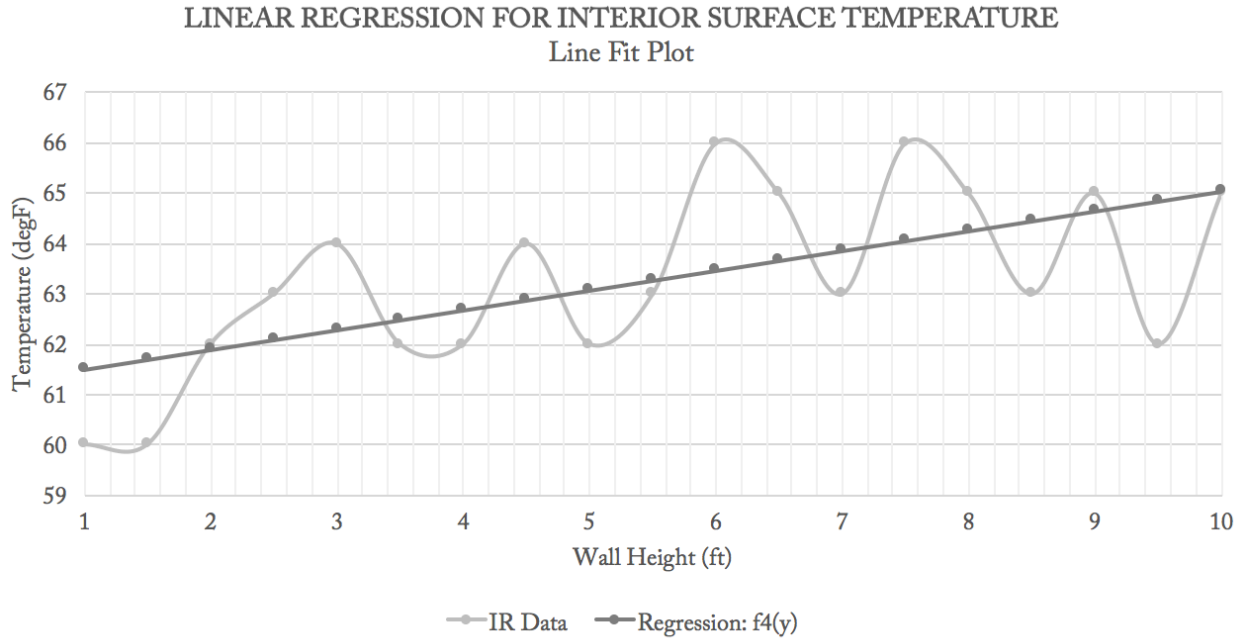
Using a linear regression based on infrared thermography plots of the interior and exterior walls, the two temperature functions were determined to be:

Figure 21: Interior surface linear regression

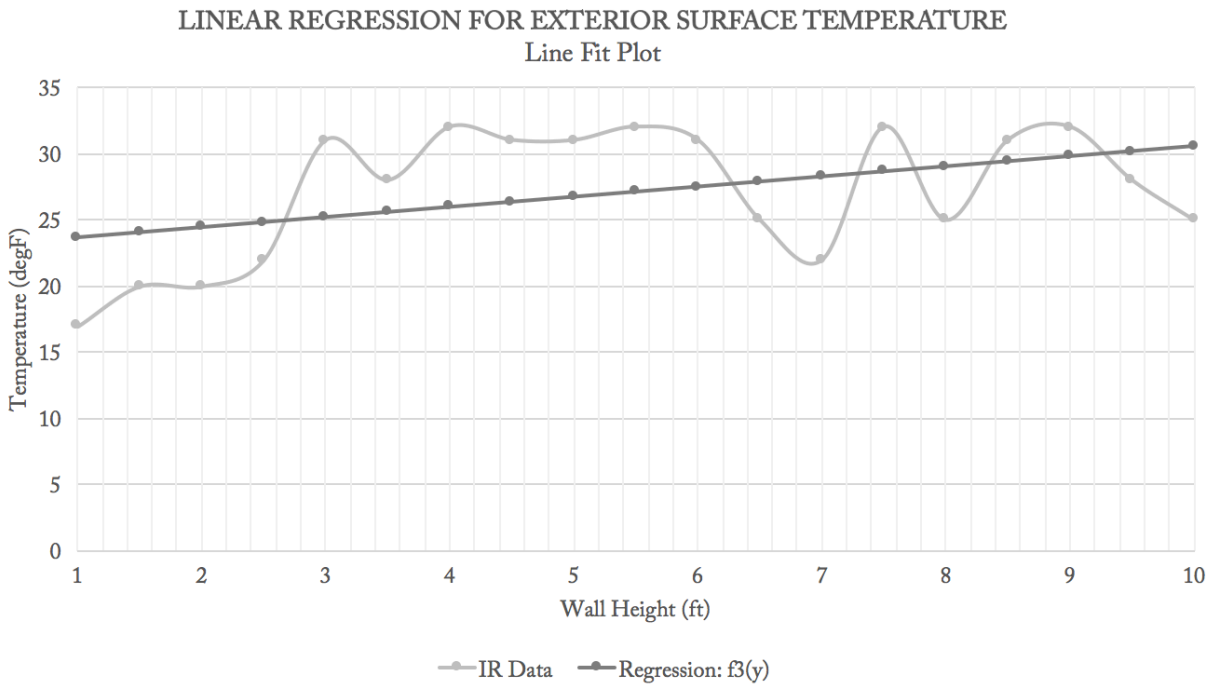
Figure 22: Exterior surface linear regression

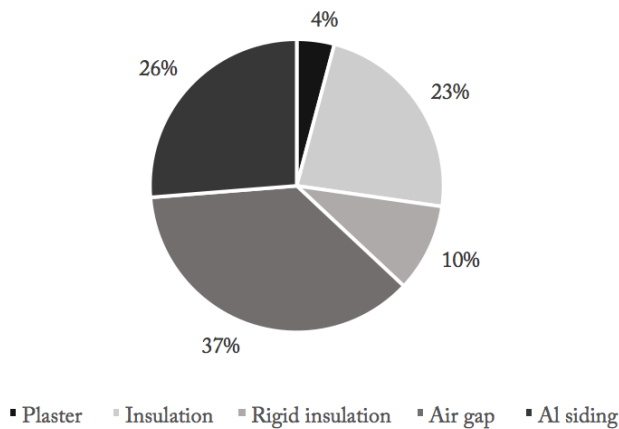
PERCENTAGE OF HEAT FLOWS BY LAYER
Two Dimensional Manual Calculation

Note from above, the interior and exterior temperature distributions are not identical as expected for a uniform wall assembly without air gaps. However, since the mineral wool cavity insulation was found in a deteriorated state, the effects of natural convection within the wall enclosure are likely more prominent due to this empty cavity. In this case, wall sections 2 (cavity insulation) and 4 (vented air gap) are assumed to be comprised primarily of air. Although the aluminum siding is more thermally conductive than the air gap, the air gap results in greater heat loss due to the greater thickness of the air gap in the direction of heat flow.

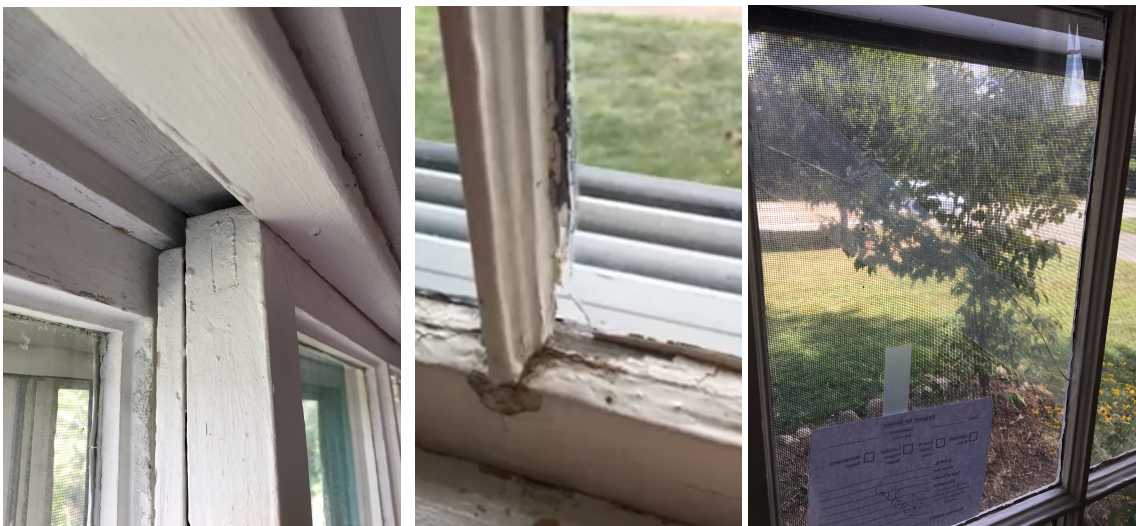
Preliminary blower door studies conducted for this research occurred in August 2017. Initially, measurements were taken with no modifications to the building other than mandatory building preparations such as covering exhaust ducts and shutting down natural gas equipment. Refer to the photos in Figure 24 for examples of envelope deficiencies. As indicated by Table 14, the record air leakage at 50Pa is agreeable with the final value recorded in 2007. Surprisingly, the building envelope appears to have experienced minimal infiltration depreciation over the last ten years.

Figure 24: Solarium window gap (left); pane glass crack and deteriorating caulking (middle); pane crack (left)

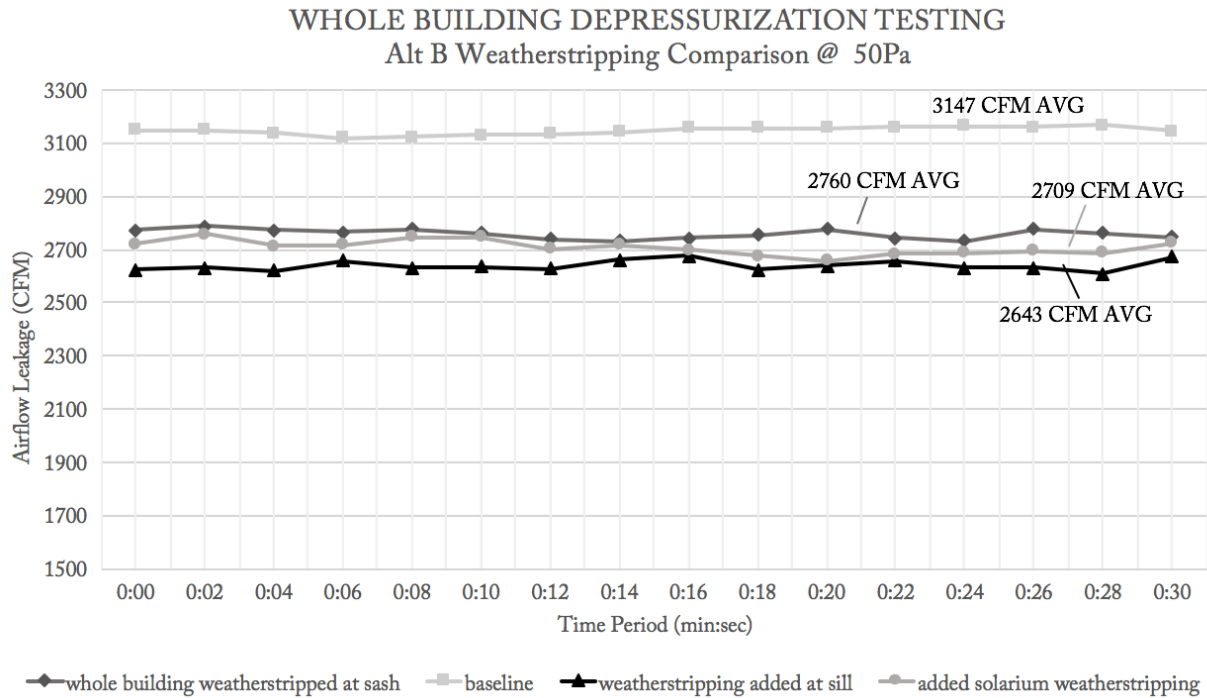
The average leakage rates and observed leakage locations are shown in Table 14. Leakage behavior over the sample periods are shown in Figure 25 for each test case.

Figure 25: Whole building depressurization test for weatherstripping

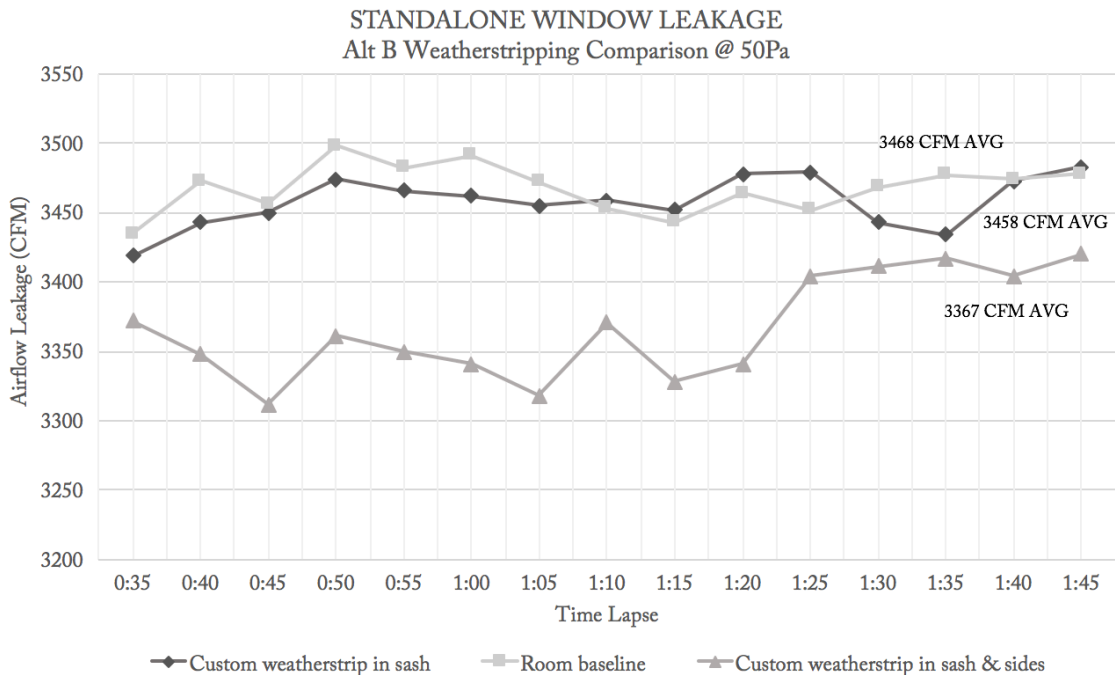
Visual representations of the blower door results are shown in Figure 26 over a one minute sample period. Per the Passive House standard, measurements are taken at a building pressure of 50Pa as a control. The standalone study for weatherstripping involved installing a control window in the frame of a one window bathroom at the Gibbs House. First, testing was conducted without the window installed (room baseline). Then, the window was installed with EPDM weatherstripping at the sash. The next round of testing included adding weatherstripping to the side gaps of the double hung window. There was very little drop in airflow with just the weatherstripping installed at the sash. However, the combination sash and sidewall weatherstripping provided a small drop in airflow (3%).

Figure 26: Standalone window comparison for weatherstripping

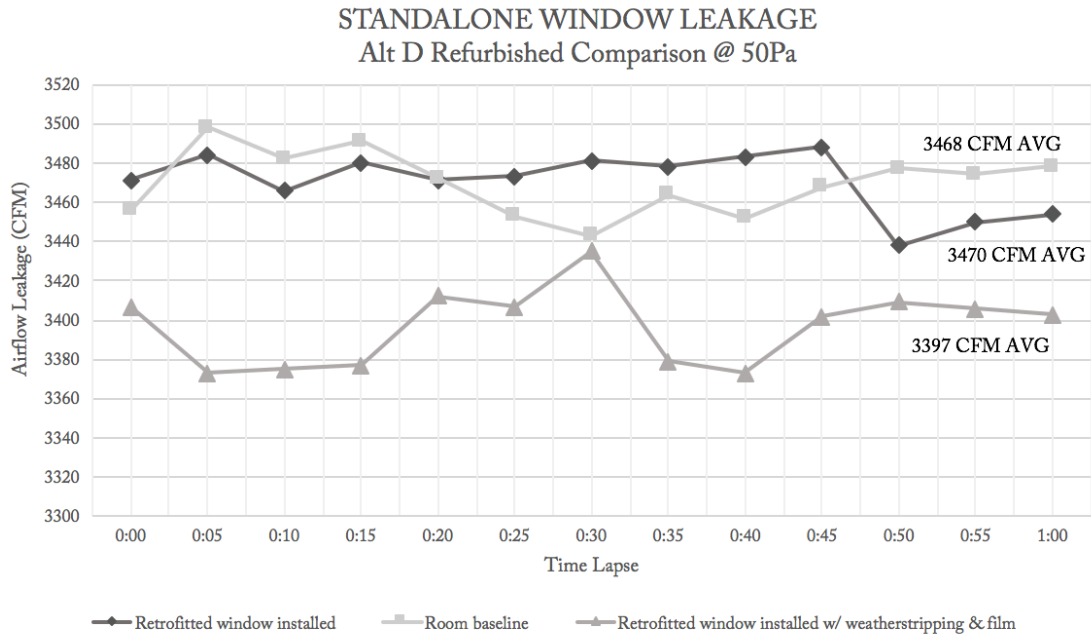
The same process was employed for refurbishing a window. The refurbishing process included deconstructing the window by removing old caulk and then recaulking to secure the existing glass panes. The window was then installed under the same conditions and compared against the room baseline. The retrofitted window provided no decrease in airflow compared to the baseline, likely due to the poor original frame construction that is difficult and timely to repair. Improving this aspect of the window would essentially result in building a new window. However, a small drop in airflow (2%) was observed when weatherstripping and film was provided for the window.

Figure 27: Standalone window comparison for refurbishing

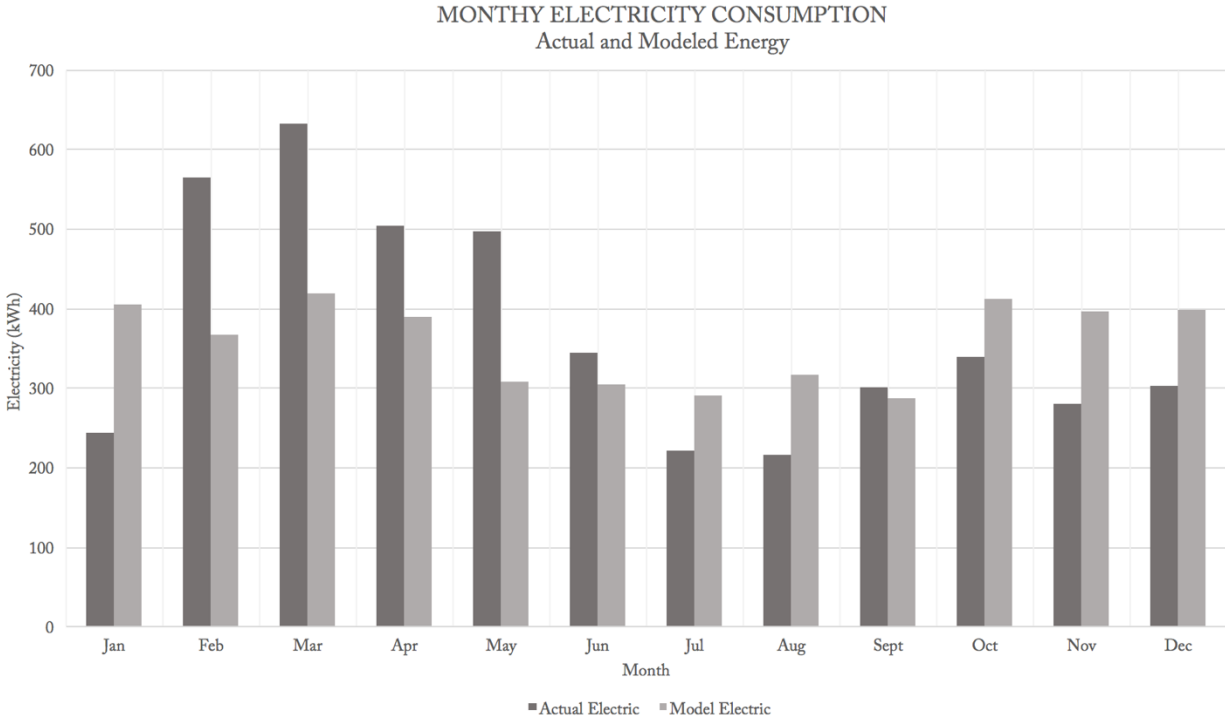
On an annual basis, the modeled electricity uncertainty compared to actual gas consumption from the previous year is 3.13%. Since estimated cost savings and simple payback times are analyzed in this report on an annual basis, the uncertainty is assumed to be agreeable for comparative purposes. The model runs according to a typical residential schedule expected by the residents: occupied on weekends and on weekdays after 5 PM. Occupancy levels were modeled at a lower value for the months of June, July and August to reflect no permanent residents and only permaculture team members and site volunteers. Actual energy patterns experience peak values from February through May whereas the model reveals a relatively consistent energy use across all months. This is likely a result of unforeseen fluctuations in energy use due to events and potlucks, staff and student meetings, and impromptu office space for staff due to weather during normal business hours where the building would otherwise be unoccupied. Since the only building equipment that relies on electricity is lighting, exhaust fans, appliances, pumps and other plug loads, the discrepancies can be associated with the occupancy swings, as discussed.

Figure 28: Actual and modeled monthly electricity consumption

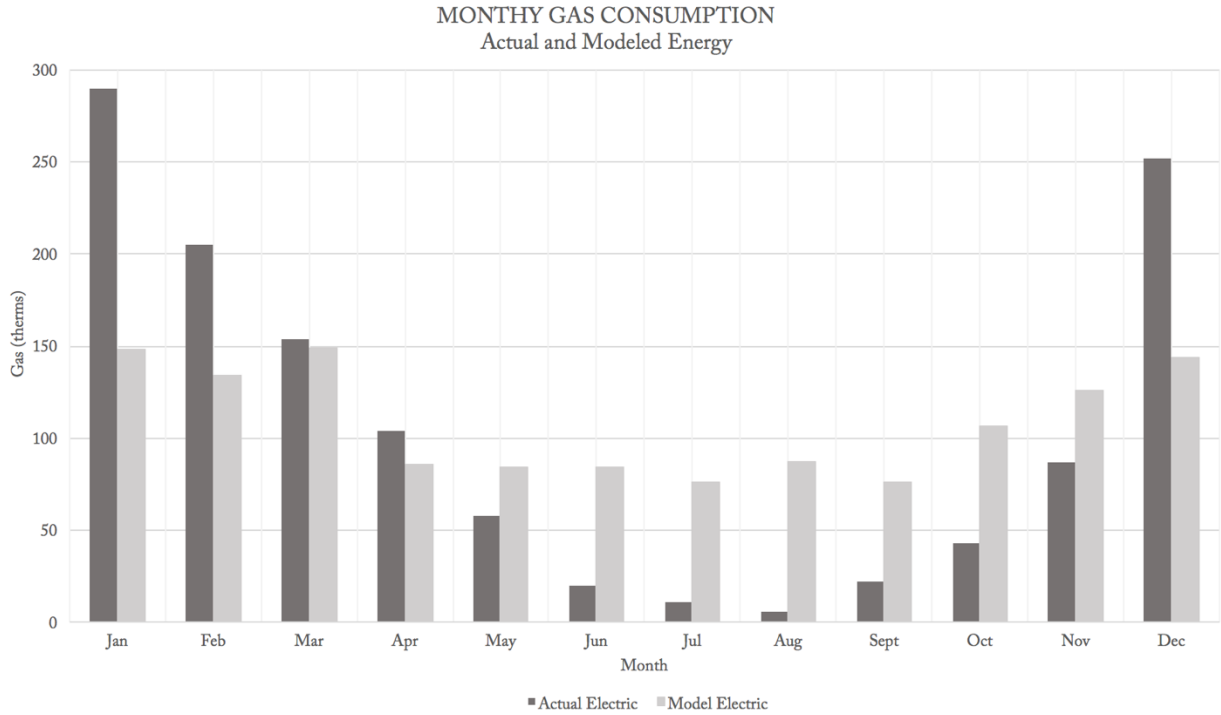
Modeled gas consumption uncertainty compared to actual gas consumption from the previous year is 4.5% on an annual basis. Similar to electricity use, the model reflects a more consistent energy use pattern across all months. Whereas actual gas use reflects very large swings across summer and winter months. During the two coldest months, December and January, heating equipment is operating at maximum capacity, as reflected by the very high gas usage and failing to meet occupant needs through ineffective perimeter heat. Additionally, domestic hot water is provided by the natural gas water heater which experiences demand peaks during these colder months. Major drops in energy usage are observed during the summer months are also observed due to no cooling equipment being present in the building. Since the boiler and water heater are the only equipment that rely on natural gas in the building, there is virtually no demand when residents are not present to initiate a call for heat. The model is conservative in projecting gas usage during these warmer months due to visitors.

Figure 29: Actual and modeled monthly gas consumption

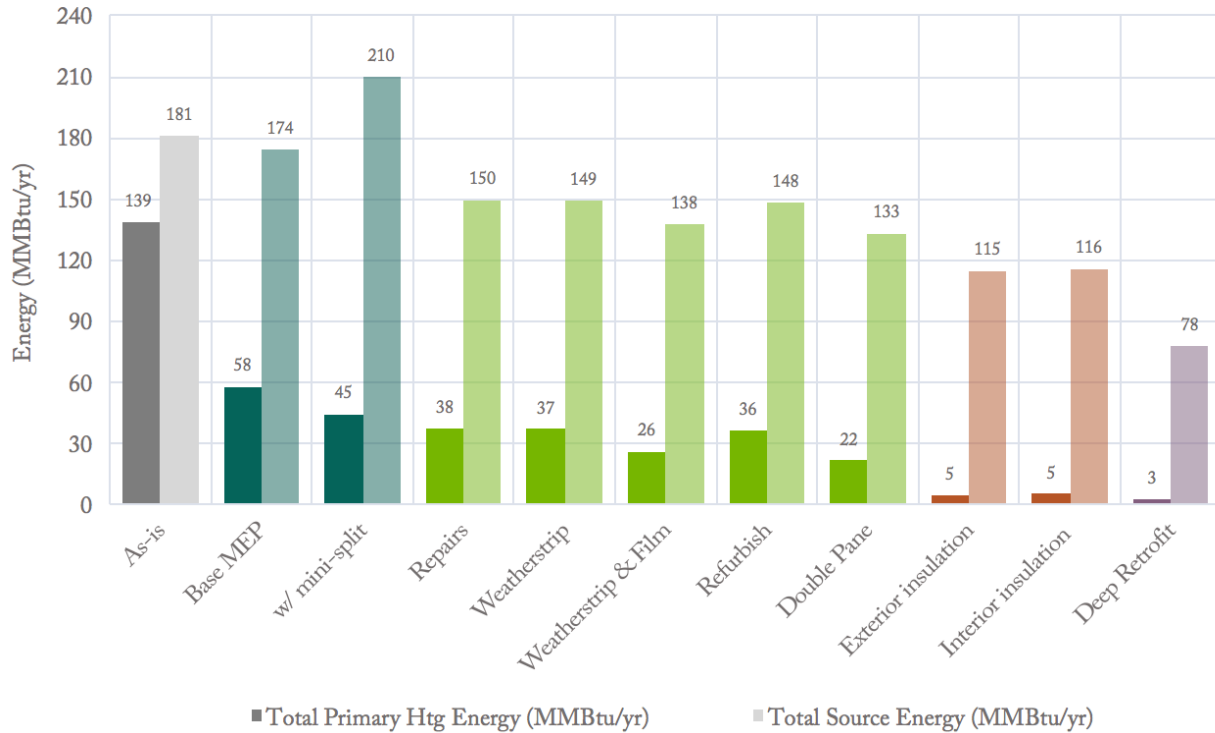
MODELED ENERGY CONSUMPTION All Base Alternatives Comparison

Figure 30: Modeled energy consumption by alternative

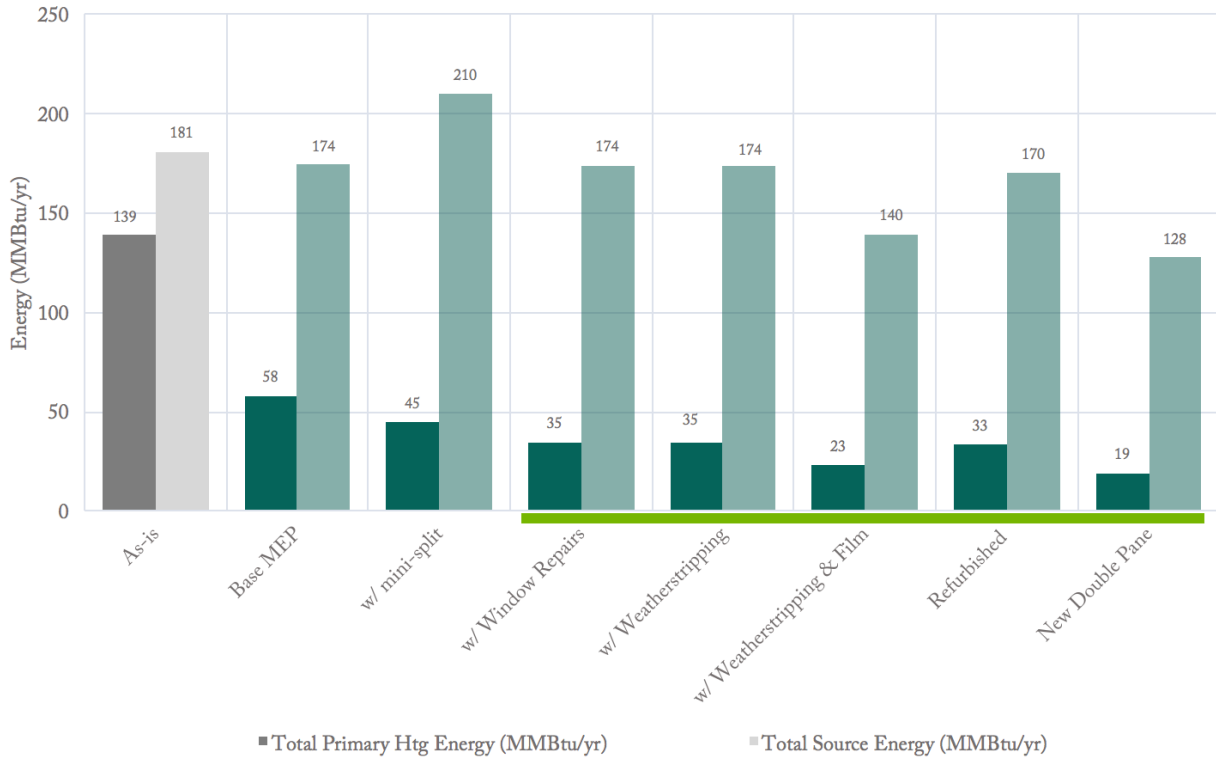
MODELED ENERGY CONSUMPTION MEP Upgrade Alternatives Comparison

Figure 31: Modeled energy consumption for MEP upgrade options

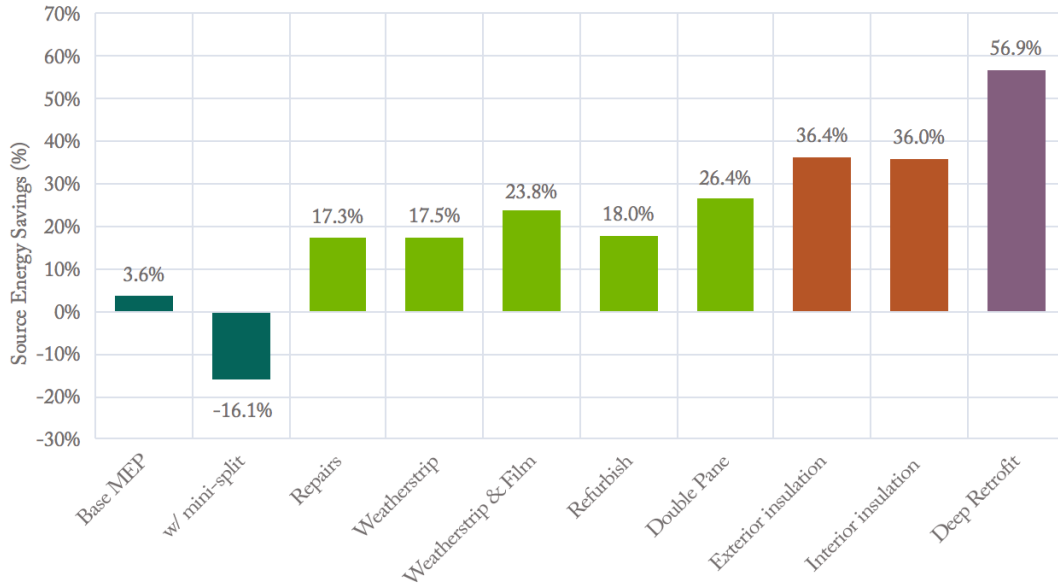
SOURCE ENERGY SAVINGS Compared to Modeled As-Is Energy Source Consumption

Figure 32: Source energy savings percentages

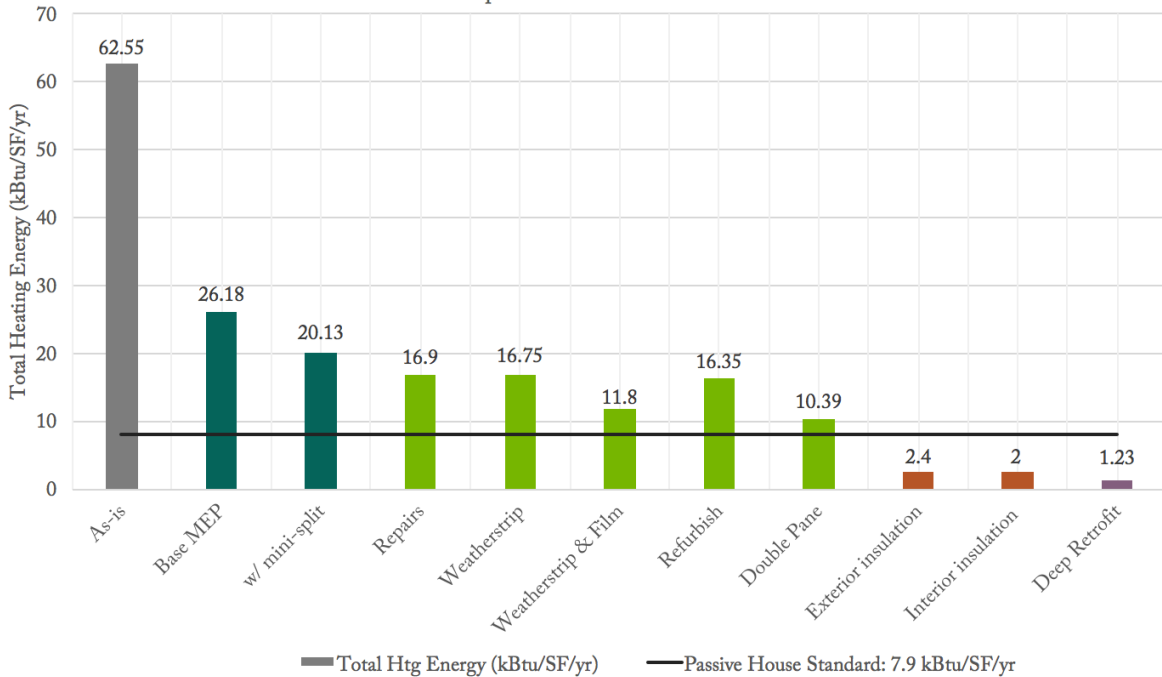
TOTAL ANNUAL HEATING ENERGY PER SQUARE FOOT Compared to Passive House Standard

Figure 33: Total annual heating energy compared to Passive House standard
