Gibbs Passive House Study:
A case study approach for a historic residential
energy efficiency renovation

A thesis submitted to the Graduate College
in partial fulfillment of the requirements
for the degree of Master of Science in Engineering (Mechanical)
Mechanical and Aeronautical Engineering
Western Michigan University
December 2017

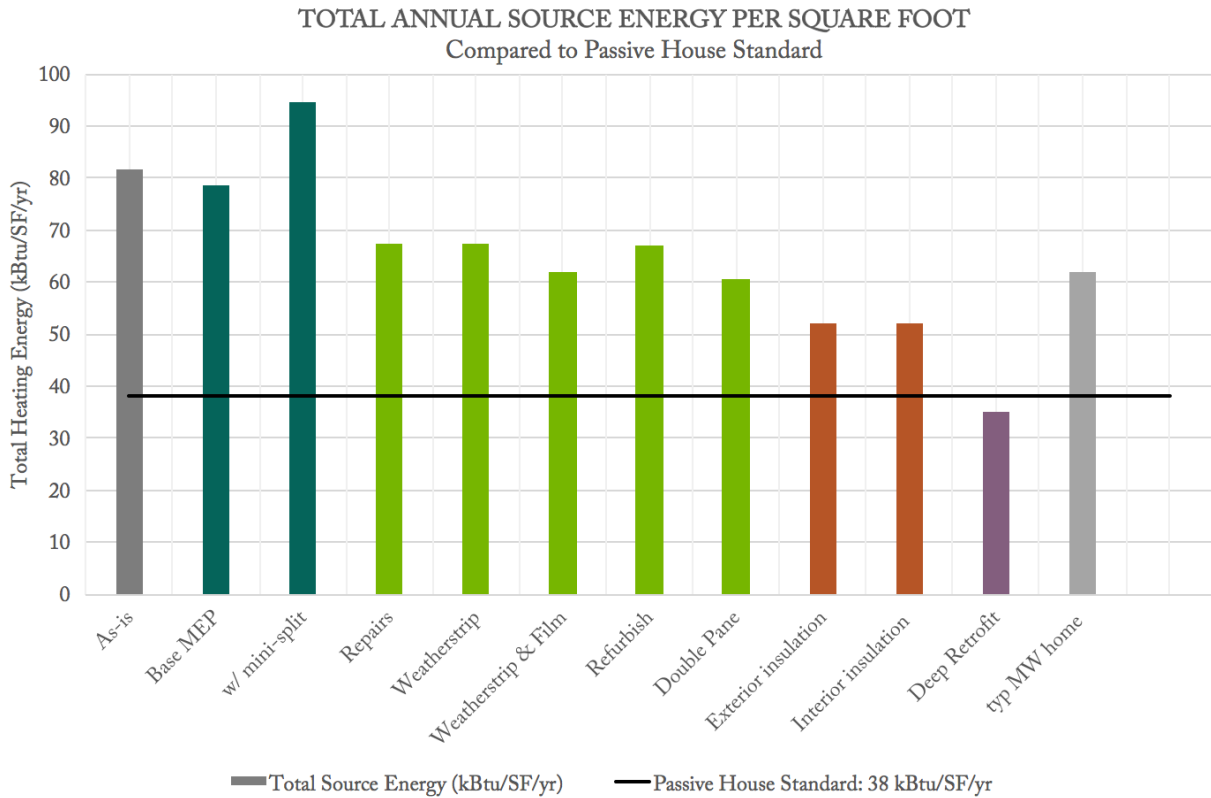
A similar phenomenon occurs for total annual source energy: Alternative 5 is the only option that achieves the Passive House metric. Alternative 5 includes exterior insulation and new siding, new mechanical upgrades, and new double pane windows.

Figure 34: Total annual source energy compared to Passive House standard

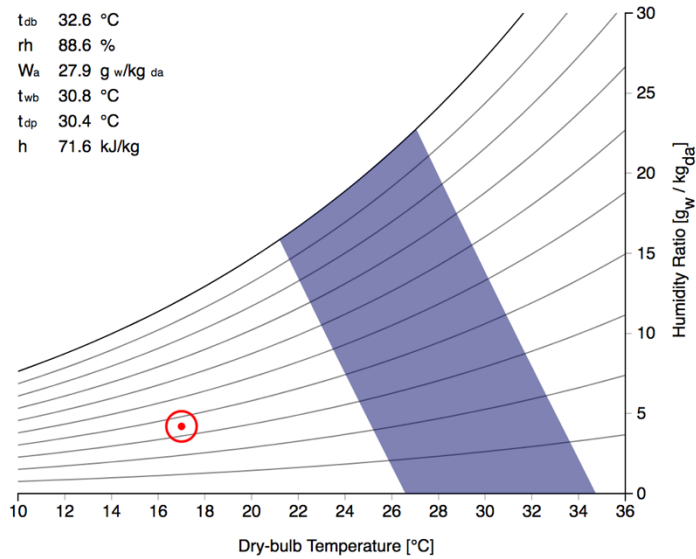
The CBE Thermal Comfort Tool provides an informational interface to determine compliance with the ASHRAE Standard 55-2013. As shown by the psychrometric chart in Figure 35, the Gibbs House does not meet compliance with the Standard due to cold thermal radiation sensations, and a dry bulb temperature (red dot) outside of the target region (purple shading). The instance shown is for the heating season where the air temperature is 62.6 degF, the mean radiant surface temperature is 66 degF, and the average relative humidity is 35%RH. The sensation determined by the comfort tool was cool.

Figure 35: As-is thermal comfort results

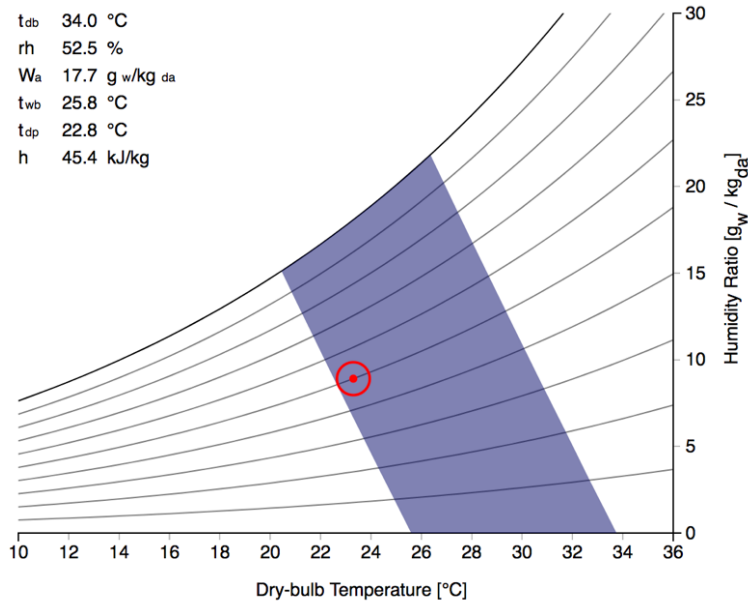
After implementing exterior wall insulation and installing an energy recovery unit, the building is likely to meet ASHRAE 55 compliance as shown in Figure 36. The WMU standard for occupancy temperature setpoints are 71F and 74F for heating and cooling, respectively. Thus, these setpoints are recommended for initial control sequences for the building. An air temperature of 74 degF was utilized to meet the standard setpoints. Since the building use is residential, these setpoints are adjustable. The minimum mean radiant temperature, or surface temperature, is required to be 68F in order to meet ASHRAE 55 compliance. Since the existing R-value of the cavity insulation is R-22, the insulation would have to increase to be at least R-30, as calculated by the two dimensional building envelope program developed for this study in an earlier section. Relative humidity levels are recommended to be controlled to less than 65% to reduce the likelihood of conditions that can lead to microbial growth [41]. The same metabolic rate of minimal seated work, 1.0 met, and typical winter wear, 1 clo (1.136 Btu/hr-ft²-F), were used as a control. The sensation determined by the Comfort Tool was neutral.

Figure 36: Minimal threshold thermal comfort results

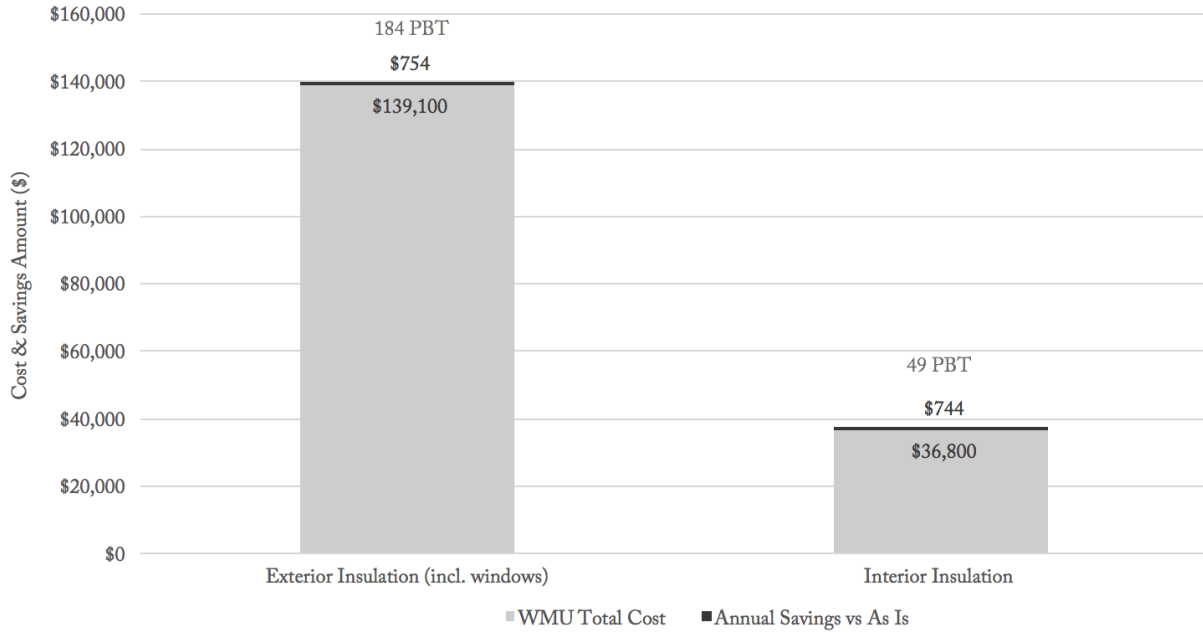
CAPITAL COST & ENERGY SAVINGS COMPARISON
Insulation, Building Envelope & Airtightness Options

Figure 37: Insulation, building envelope & airtightness capital cost and energy savings

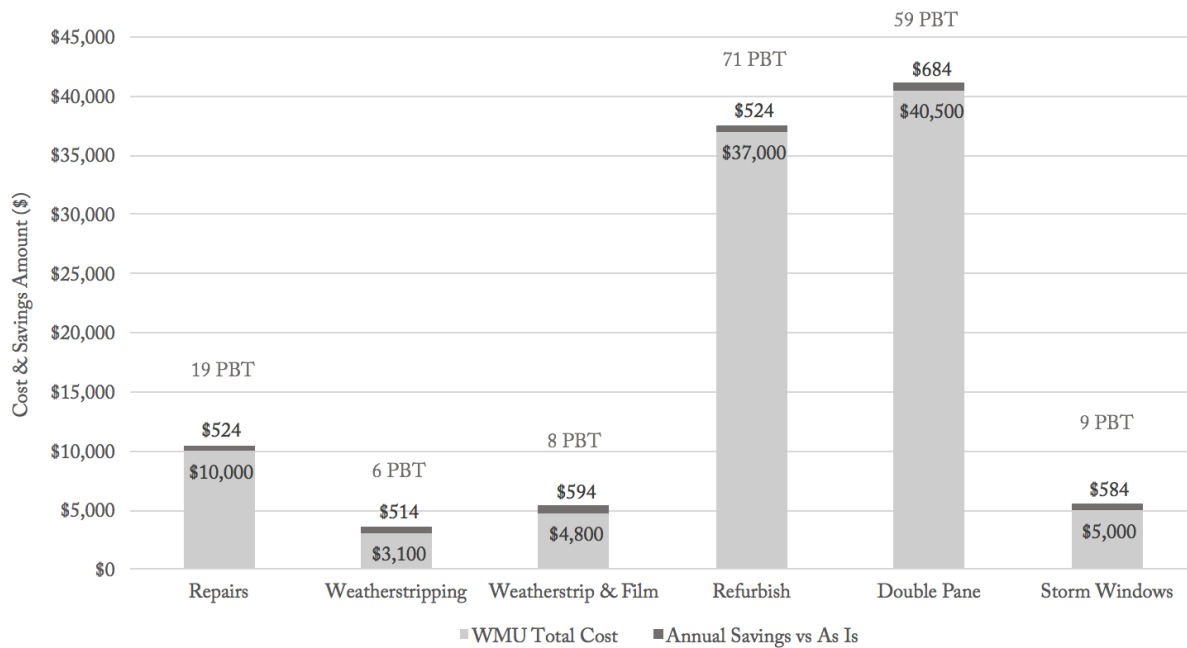
CAPITAL COST & ENERGY SAVINGS COMPARISON
Window Options

Figure 38: Fenestration capital cost and energy savings

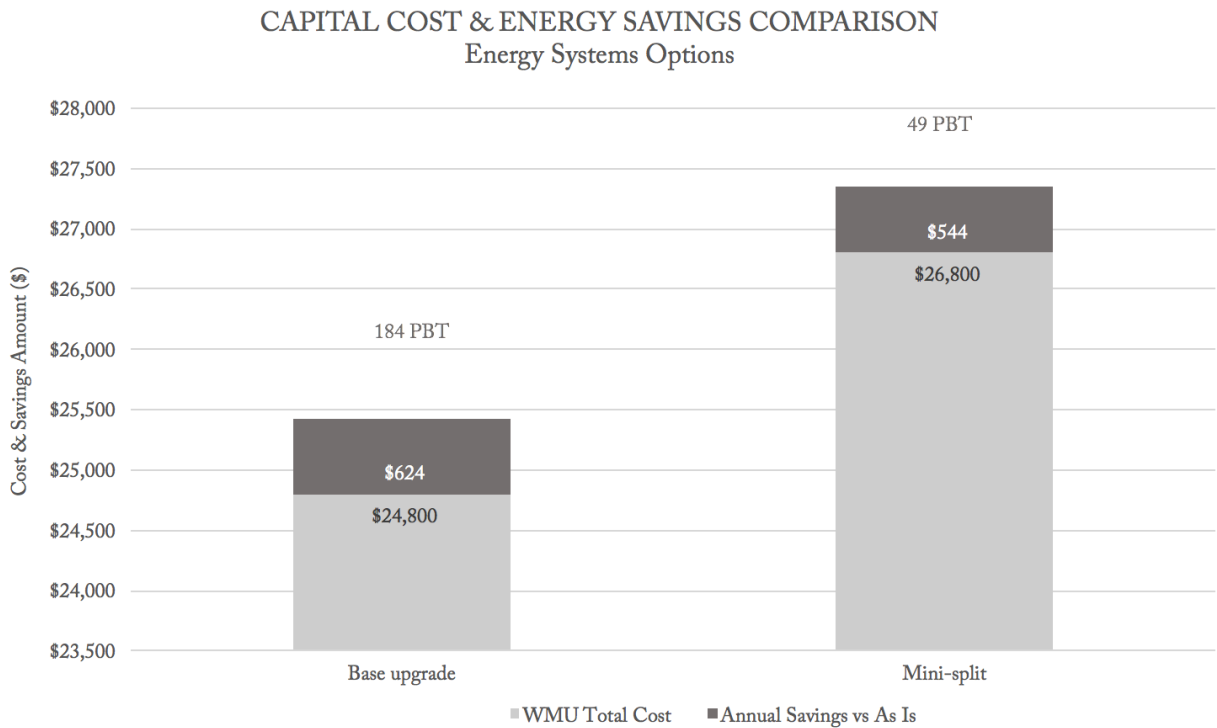
The capital cost increase for implementing a mini-split system is demonstrated by the taller bar on the right. The base mechanical upgrade includes a replacement boiler, water heater, new ceiling and attic fans, new perimeter heat, and new LED lighting fixtures.

Figure 39: Energy systems capital cost and energy savings
